HINTS FROM AUSTIN'S MORRIS GARAGE ©

Hi, everybody. This time we're covering the maintenance and repair of the Lucas Windtone horn. This horn is installed on the late MG TC, TDs, TFs, MGAs, and many other British cars. It has also been very seldom discussed.

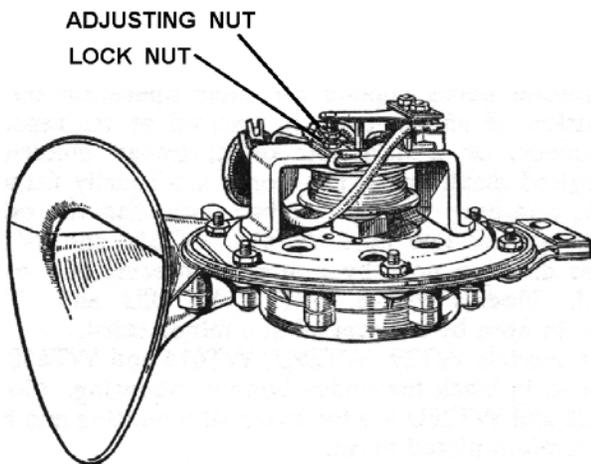
Figure 1. WT614 Horn, with Cover Removed

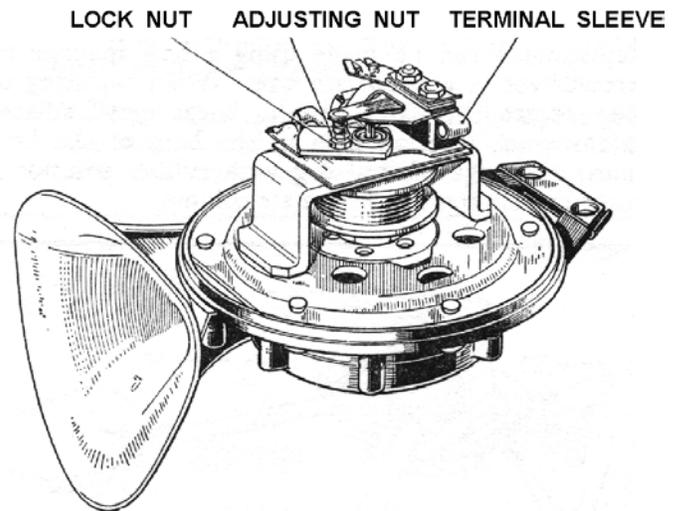
Figure 2. WT618 Horn, with Cover Removed

Note that earlier models have the base plate attached to the horn body with screws and nuts.

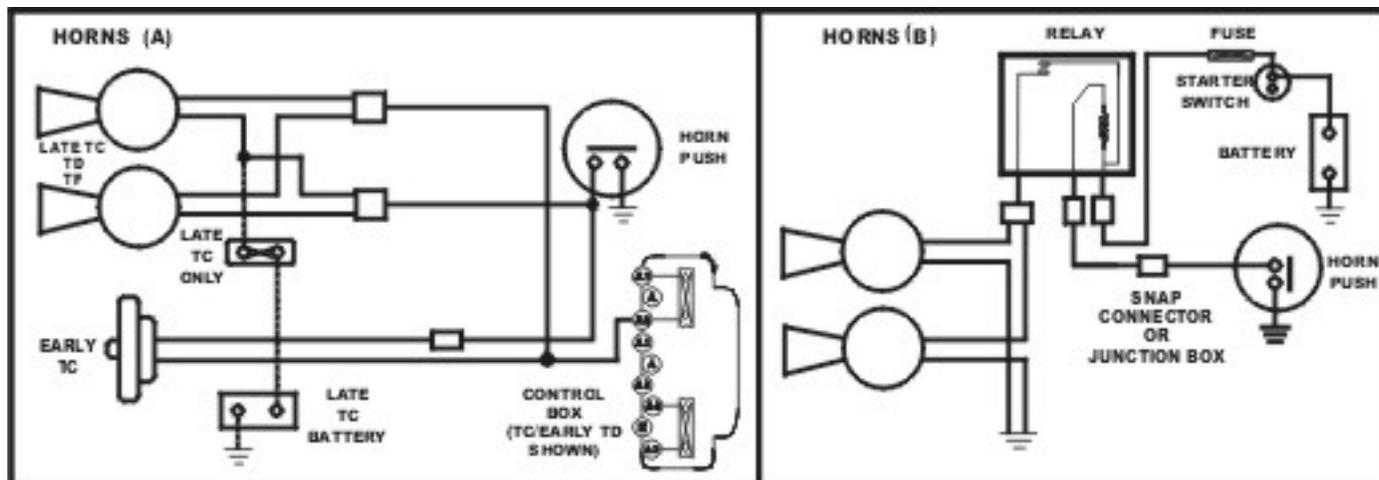
Figure 3. Typical Horn Circuit Wiring

Horns on the MG cars are generally connected directly to a 12-volt source, thus are "hot" all the time (see schematic HORNS (A) in Figure 3).

On other cars, a relay is used to minimize the current carried by the horn contacts and to reduce the voltage drop in the horn wiring (see schematic HORNS (B) in Figure 3). If desired, the direct-connected horns may be wired this way, too.

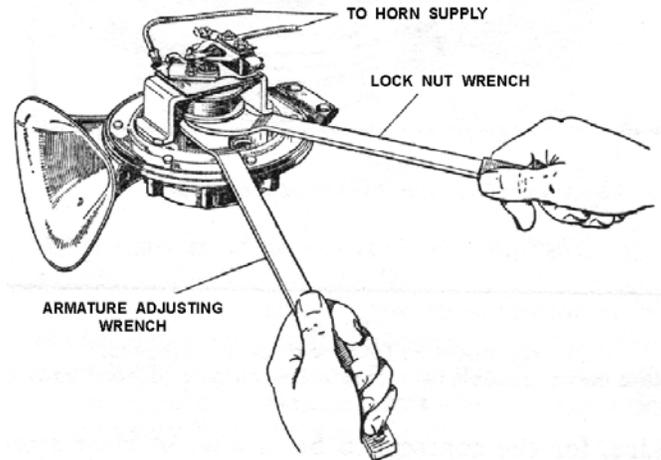
Figure 6. Adjusting the Armature

1. Slacken the armature lock nut.
2. Reset the armature, using the tools, as in Figure 6.

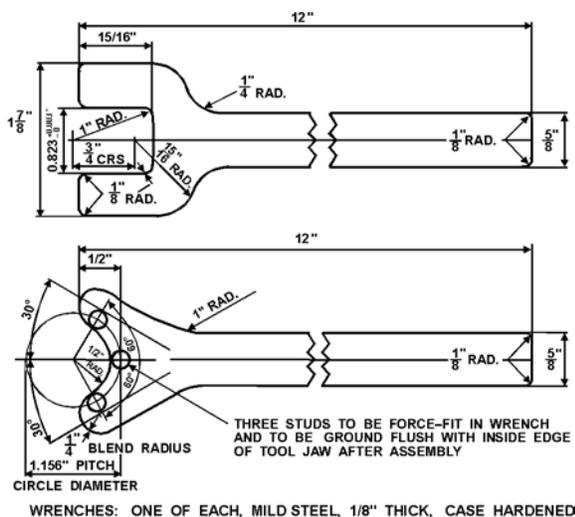
Figure 5. Adjusting Tool Dimensional Drawings

Figure 5 shows two special tools required for making armature adjustments on WT614 (top) and WT618 horns.

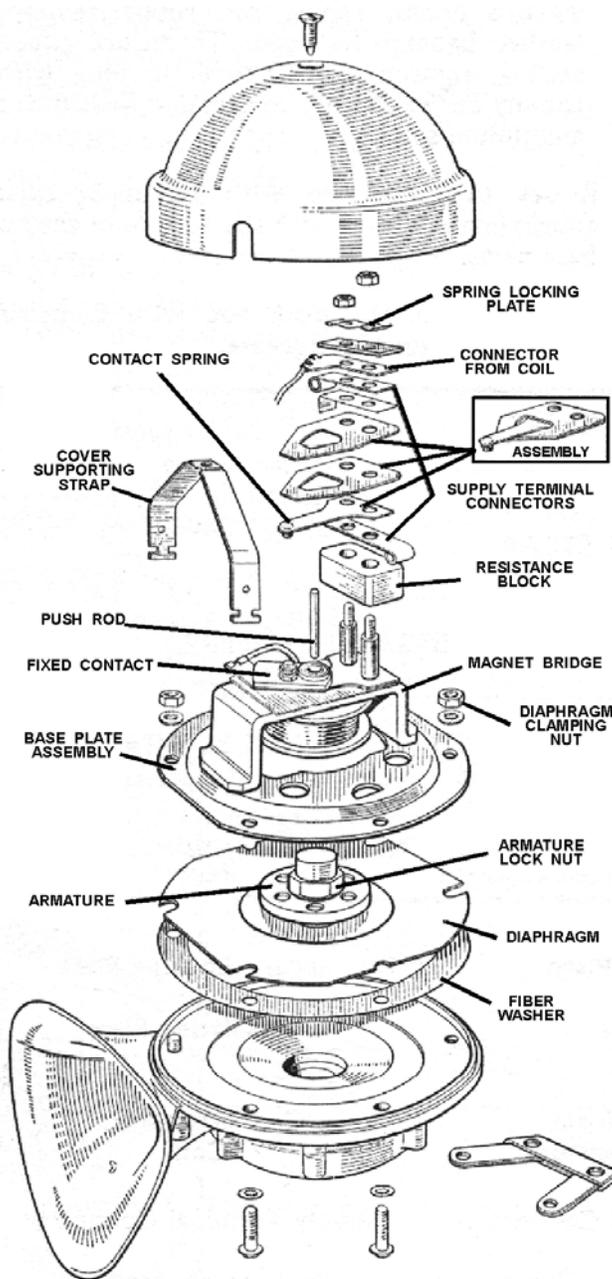
Figure 7. WT618 Shown Disassembled

Unless a major fault occurs, such as a broken diaphragm or a burned out coil (both of which are very rare faults), dismantling of the movement itself is not advisable. If however, dismantling is necessary, refer to Figure 7, and follow the order of disassembly in Figure 8. When a horn coil housing and base plate is affixed to the die cast body with rivets, the rivets must be drilled out. To reassemble, reverse the order in Figure 8. Upon reassembly, the holes must be drilled out to 7/32 in., and the rivets replaced by appropriate machine screws and nuts.

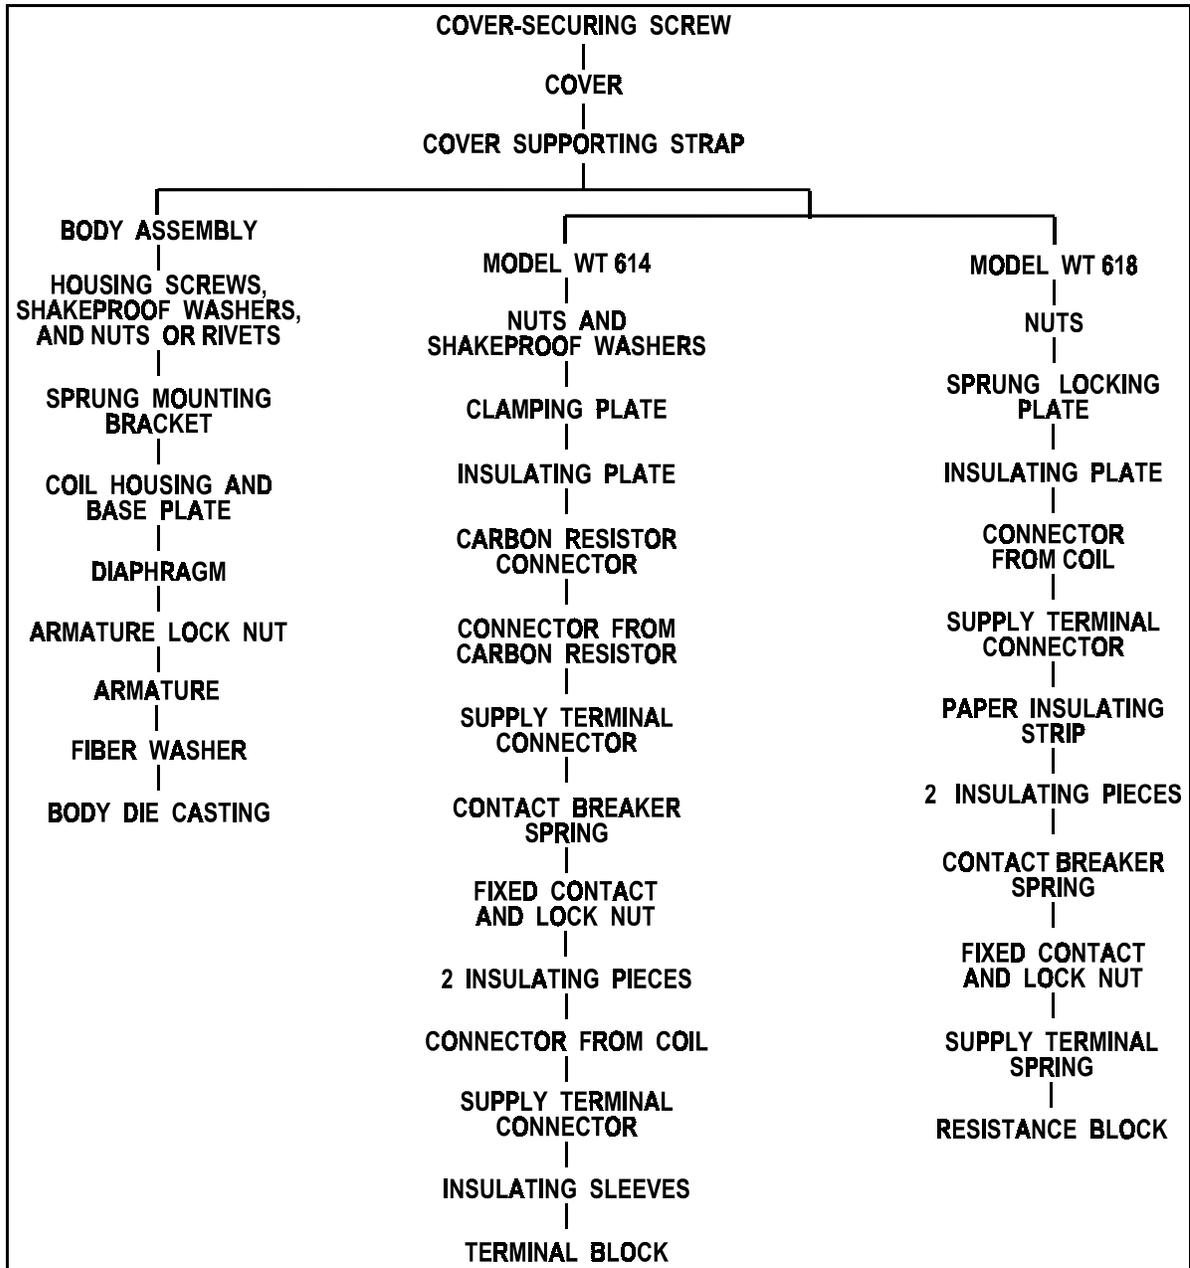
Figure 8. *Dismantling and Reassembly Sequence*
